## Engineering Change Notification

Reference number: R&D/CCD/Ecn-04/07  
Date/Issue: April 2007 Issue 1  
Part: Z-Hub/9

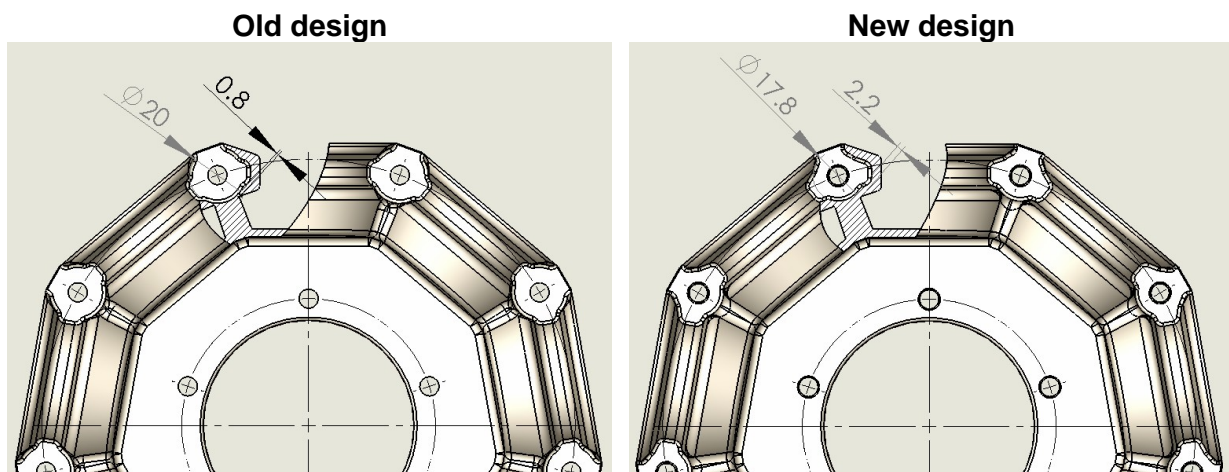
## 1. Reduction of socket clearance at outer bolt circle

A number of field failures have revealed a weak spot in the hubs, which under severe dynamic loading can be the starting point of fatigue cracks. The cutaway around the bolt holes in the outer bolt circle to give space for large washers and for a socket wrench has caused the wall thickness of the blade socket to be only 0.8mm in a small region. The clearance around the bolt hole will therefore be reduced to increase the wall thickness in this area.

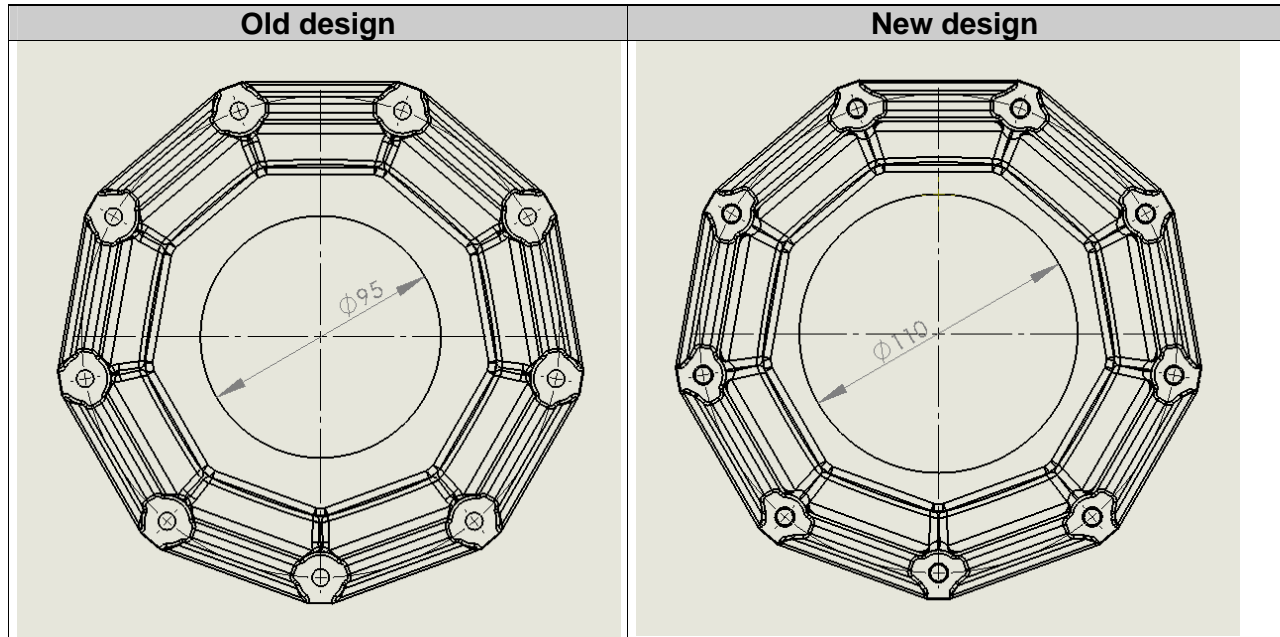
## 2. Increased coupling diameter between hub and retainer

To increase the free area for machining of mounting holes the coupling diameter is changed from  $\text{Ø}95\text{mm}$  to  $\text{Ø}110\text{mm}$ , which is the maximum possible with the current mould design.

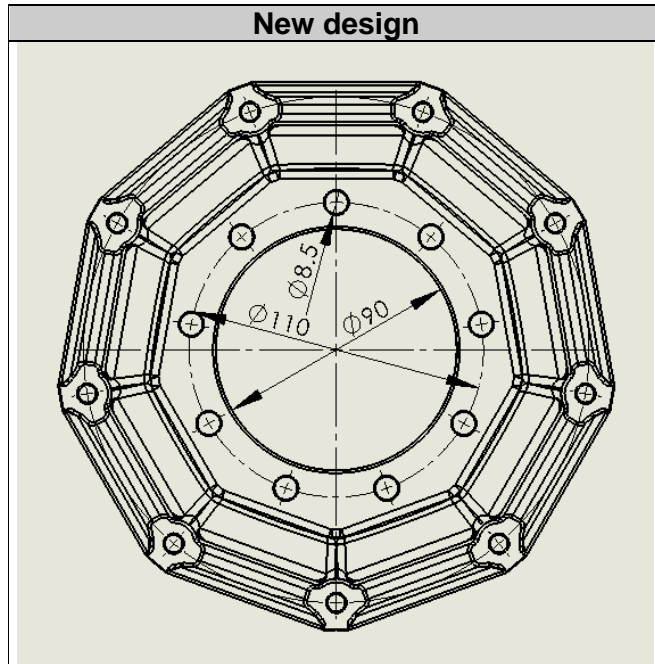
### 3. Z-Retaining Plate/9/000090

The parts Z-Hub Plate/9/90/9x8,5/BC110 and Z-Retaining Plate/9/9x8,5/BC110 will be replaced by Z-Retaining Plate/9/000090.
